Solid Bonded Films or Monolithic Ceramics in Tracked Chains of Construction Equipments for Wear Management

M. Ketting, F. Tintrup
IBAF GmbH
Universitätstr. 142
D-44799 Bochum

Paper presented at the RTO AVT Specialists' Meeting on "The Control and Reduction of Wear in Military Platforms", held in Williamsburg, USA, 7-9 June 2003, and published in RTO-MP-AVT-109.

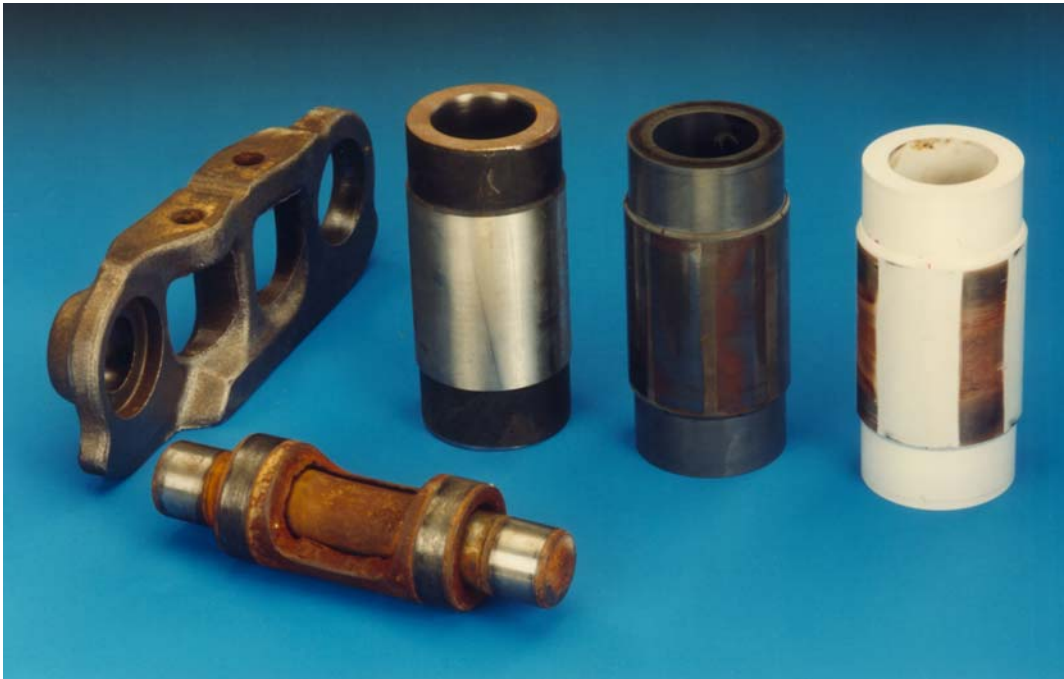
Figure 1 : D6D-Buschings in steel and monolithic ceramics having typical wear patterns and a worn D4D-Bushing

It is common practice the "turn" weared bushing in order to use them a second time. Also the operators run the machine until the bushing is completely weared-off and the sprocket runs directly on the pin (See Figure 1 and Figure 2). The oil or grease lubrication will collapse. This motivated to study dry running tracked chains.

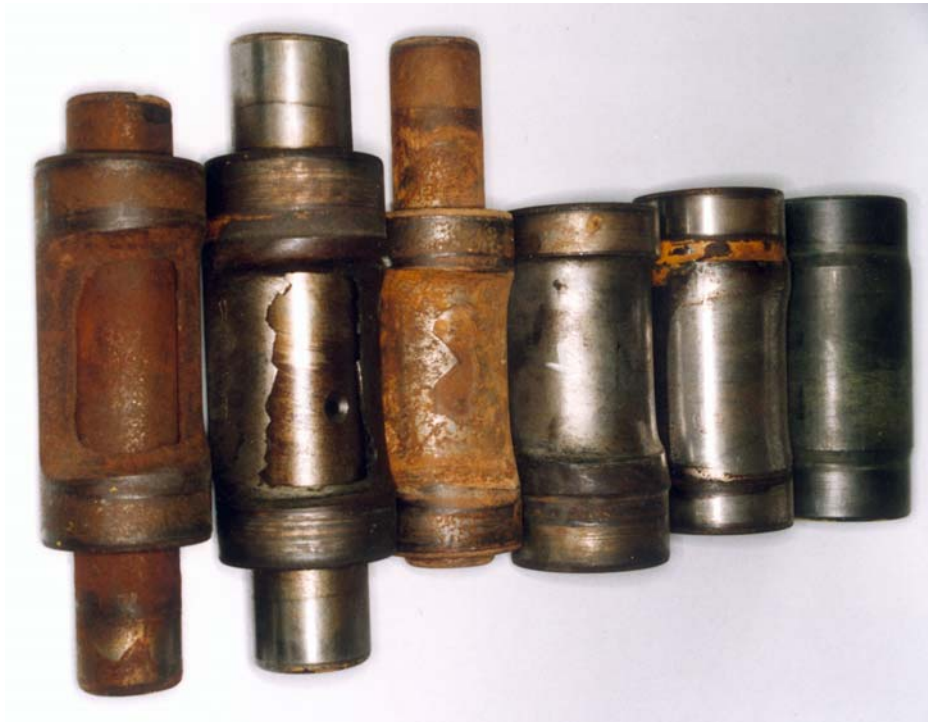
Figure 2 : Typical wear patterns observed in the field

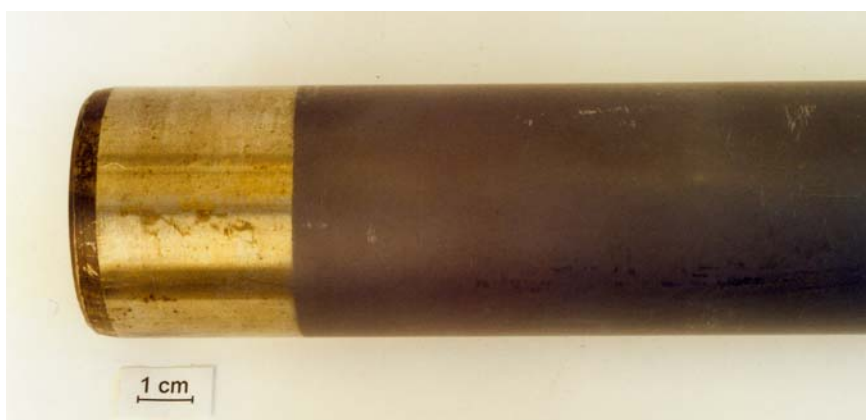
Figure 4 : Unstressed pin (D6) with Te'Strake 7409 heat curing solid bonded film

The XRD phase analysis of the tribologically stressed solid bonded films at 272 hours and 1,000 hours (See Figure 4) showed the formation of Fe_2O_3 and the degradation of the MoS_2 into $\text{Mo}_3\text{O}_8\text{xH}_2\text{O}$ (ilsemaninite, JCPDS no. 210574). Ilsemaninite, also referred to as a blue hydrogel of molybdenum oxide, is a naturally occurring degradation product of MoS_2 , with a Vickers hardness of $H_V \sim 4,800 \text{ MPa}$.

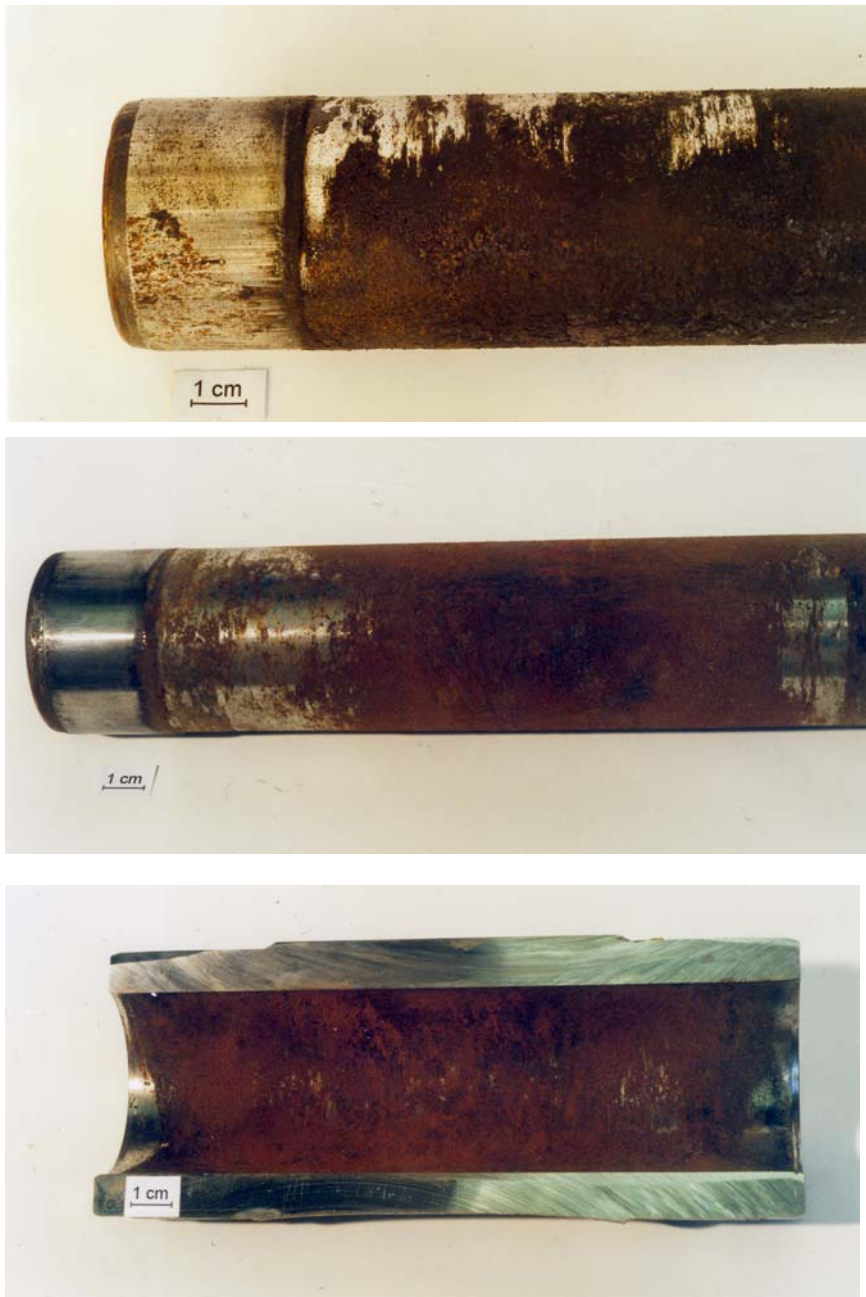
Figure 5 : Solid bonded film pin after 280 operating hours in an unsealed chain section (top). Pin after 1,000 operating hours in an unsealed chain section (centre). Inside of bush after 1,000 operating hours (bottom).

The first sections of chain were removed after just 280 operating hours. The pin surfaces had no visible solid bonded films in the wear scars, and the surface roughness was reduced to C.L.A. $\sim 0.25 \mu\text{m}$ without any indications of adhesive wear. A visual inspection of the pins and bushings revealed signs of tribo-corrosion (Rust). Corrosion processes are detrimental to coating adhesion and retention. For this reason, components will, in future, be phosphatised with "Endurion U.T.".

After 1,000 operating hours, no differences were discernible in the visual appearance of the chain sections in comparison to those inspected after 272 operating hours. However, a significant amount of MoS_2 was still in evidence in the wear tracks of the solid bonded film of the pin after 1,000 hours, indicating that not all the MoS_2 degrades. After 1,000 hours, wear had reduced the thickness of the inspected pin by less $<0.8 \text{ mm}$ (uncritical).
